December 15, 2014

**Oil leakage experienced with Evo X stock location “bolt-on” turbo upgrade kit GT/GTX30R series and GT/GTX35R series.**

**Applicable Vehicles:** 2008 and newer Mitsubishi Lancer Evolution X

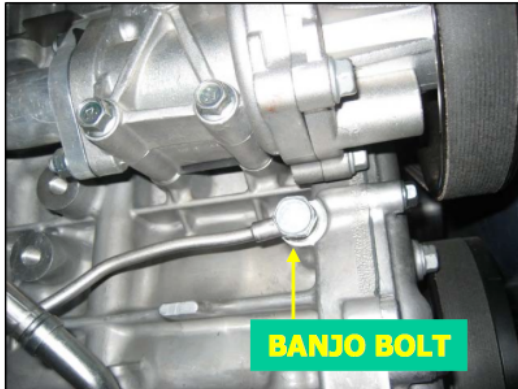
- From under the car, locate the stock oil feed bolt at the ENGINE SIDE of the oil feed line.

Note: Absent from the above picture is the turbo. This is the banjo bolt at the oil feed port on the engine.

- Remove the stock banjo bolt using a 17mm socket and driver.
- Shown below is the replacement banjo bolt next to the factory banjo bolt.
